Northern Lake Champlain Direct Drainages Tactical Basin Plan

August 2015

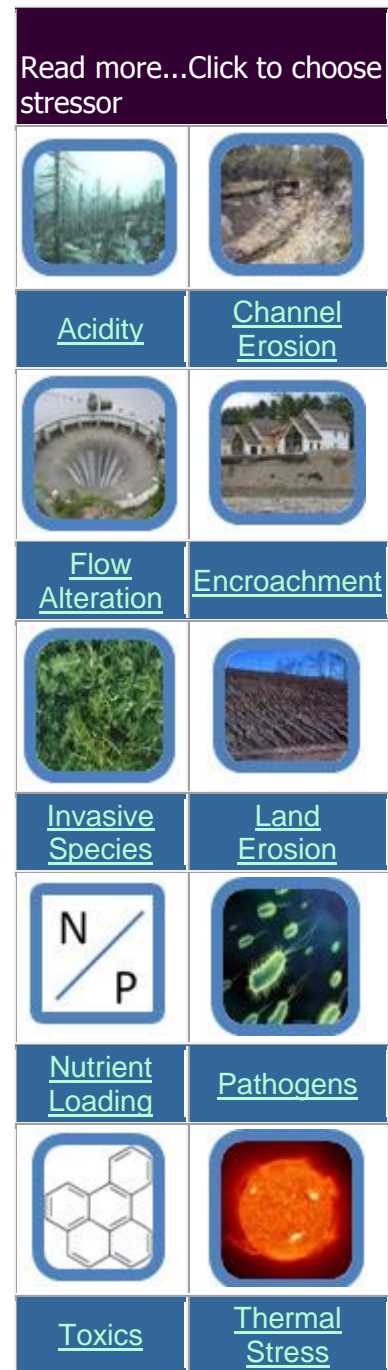
Figure 3. Stressors relating to water resource degradation with links to in-depth information.

Figure 3 provides links to the stressor chapters of the VSWMS that describe in detail the stressor, its causes and sources, and DEC's approach to addressing the stressor through monitoring, technical assistance, regulations and funding.

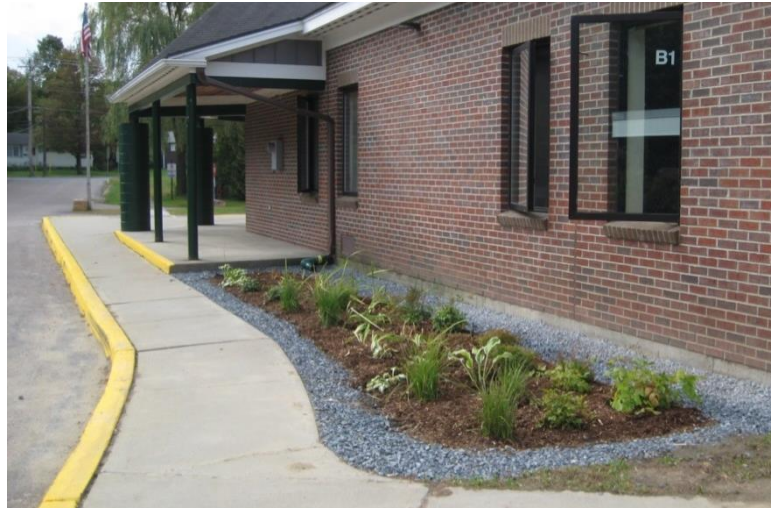
rich gravel layer under the soil where contaminants are captured. Excess water is absorbed by the plant roots.

Figure 16. Rain garden built with students at Chamberlin School, South Burlington.

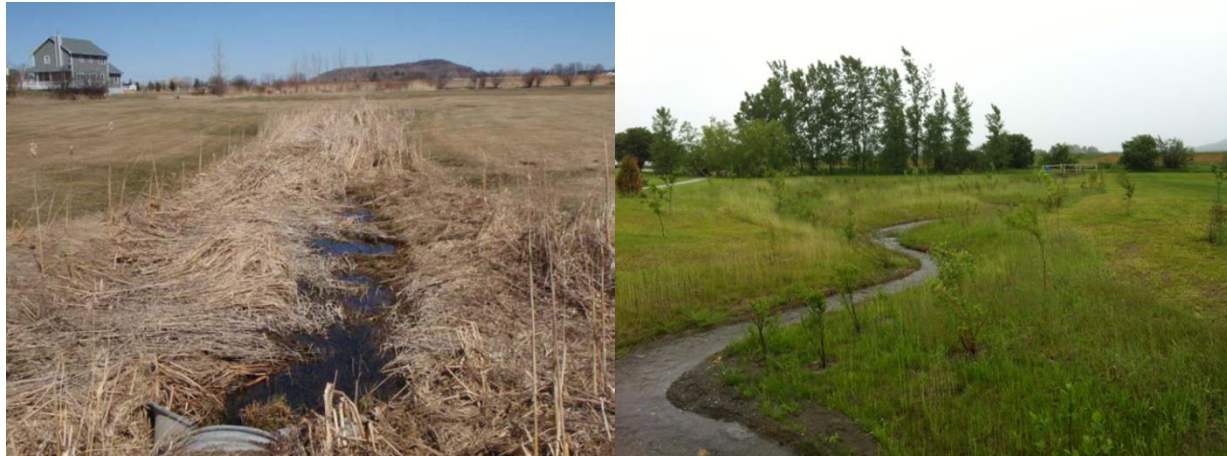
Figure 17. Before and after pictures

The North Tributary to Rugg Brook contributed to flooding problems at the Collins Perley Sports Complex and was a source of sediment and phosphorus pollution into the downstream receiving waters, which ultimately discharge into Lake Champlain. This project was designed to help alleviate flooding problems and improve water quality. The first component involved removing approximately 300 linear feet of culvert and restoring a more natural stream channel for the North Tributary at the northwest corner of the Complex. The project improved conveyance, provided flood storage in a 50 to 75 foot riparian buffer corridor, and filtered surface runoff from adjacent playing fields. The second component enhanced the function and values of the riparian area surrounding the new daylighted stream with shrub and tree plantings. The Ecosystem Restoration Program funded the project. Northwest Regional
